REPAIR INSTRUCTIONS

Hot Air Tool TRIAC AT

Serial number from 1106067414
Software version from 1.00

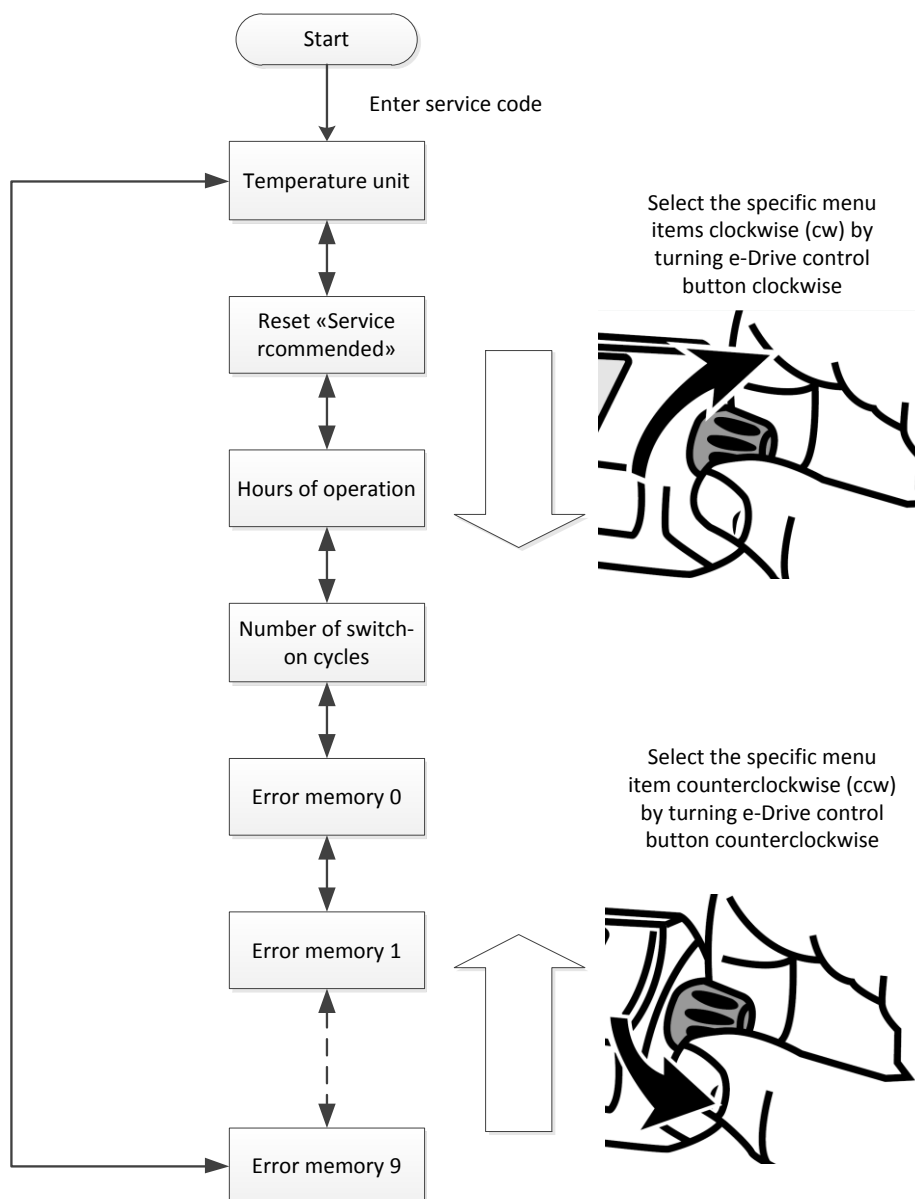
The service menu enables a selection of the temperature unit, reset of the announcement "Service recommended" and shows the error memory. Select the specific menu items by turning e-Drive control button clock- (cw) or counterclockwise (ccw). Display and setting options will be described in the following chapters.

- No heating output as long as the Triac AT is in service menu mode
- Numbers of more than 4 digits are displayed as ticker
- Quit service menu by disconnecting tool from rated voltage only

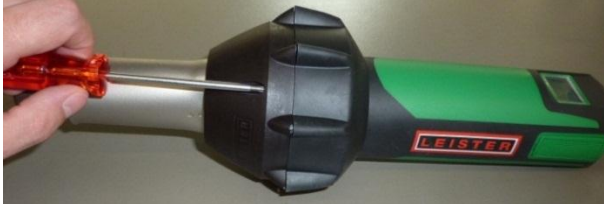
| | Loosen PT pan head cap screws KA35x20 (4x) |

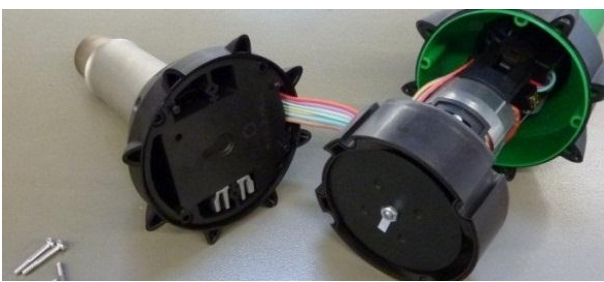
| | Put housing front aside |

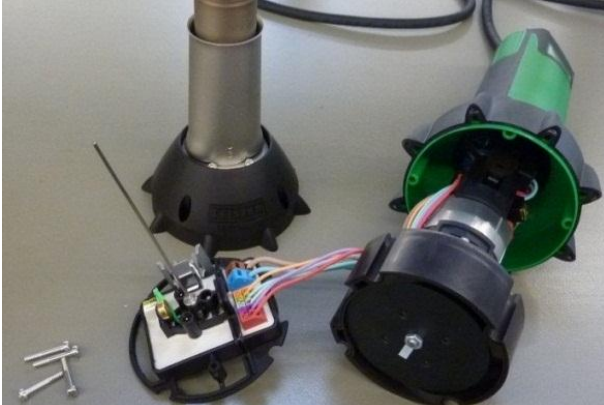
| | Extract print adapter front from blower housing top Attention: Do not damage thermocouple! |

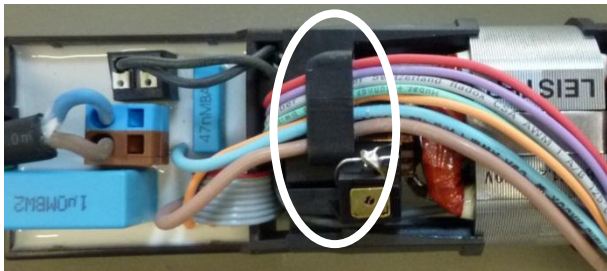
Insert flex wires in correct order in retaining bracket: Brown, blue, orange, green, grey, violet, red (bottom-up in the photo)

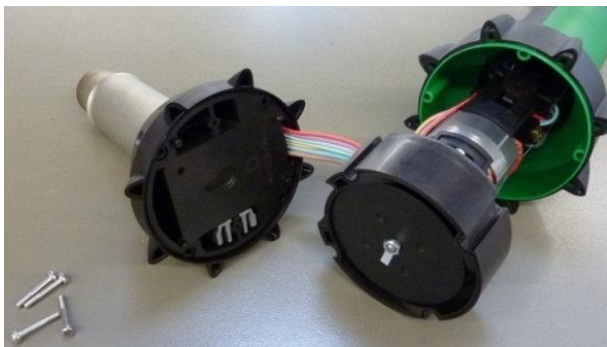
Insert print adapter front in blower housing top
Make sure groove and cam fit properly

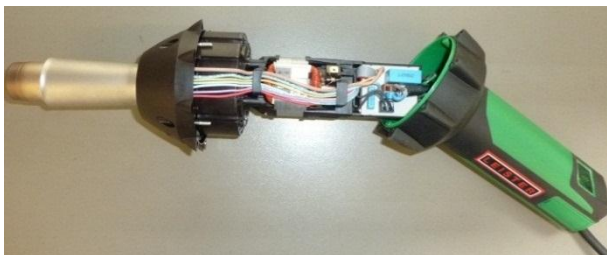
Put handle over the tool

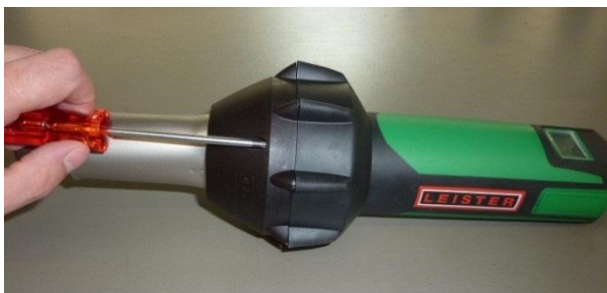
Tighten PT pan head cap screws KA35x20 (4x) to cross

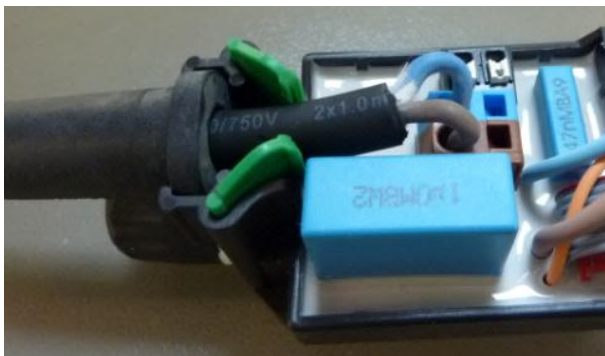
Extract power supply cord from strain relief clamps

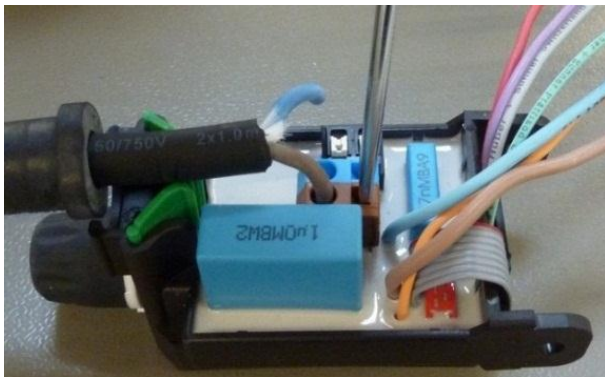
Disconnect power supply cord from terminals: Press slotted screw driver size 1 in terminal, extract flex wires

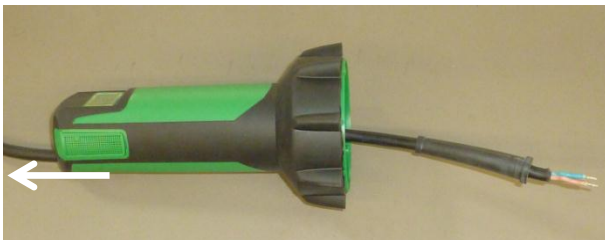
Extract power supply cord from cord guard and handle

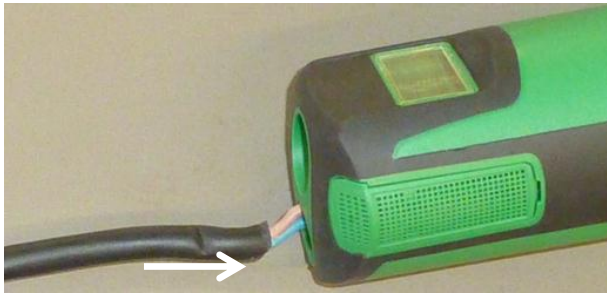
Insert replacement power supply cord from outside into the handle

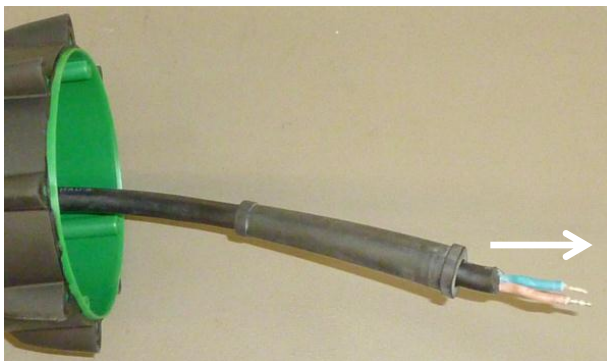
Insert power supply cord into cord guard

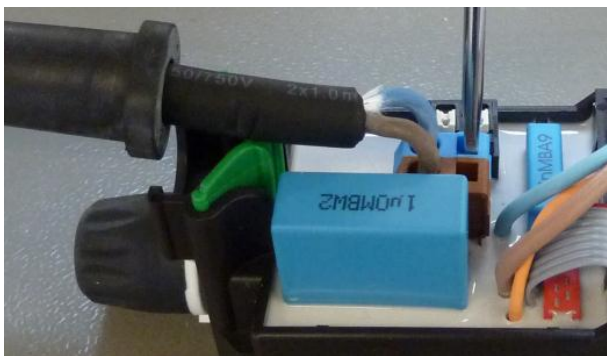
Press slotted screw driver size 1 in terminal;
connect flex wires to terminal

Keep an eye on correct color code!

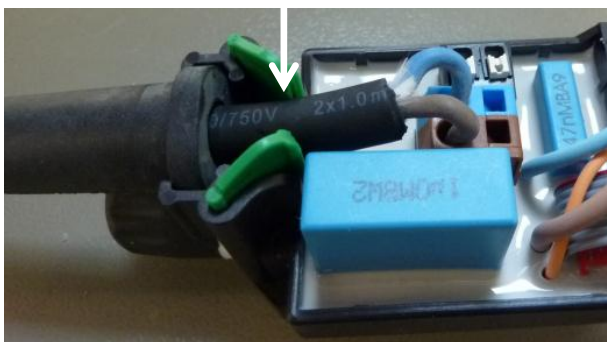
Press power supply cord between strain
relief clamps

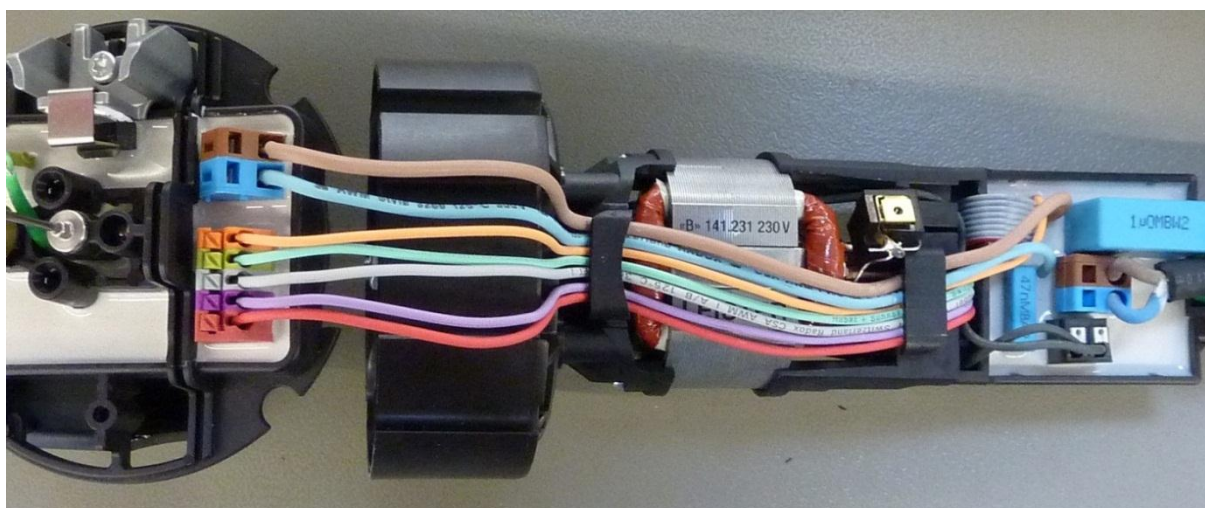
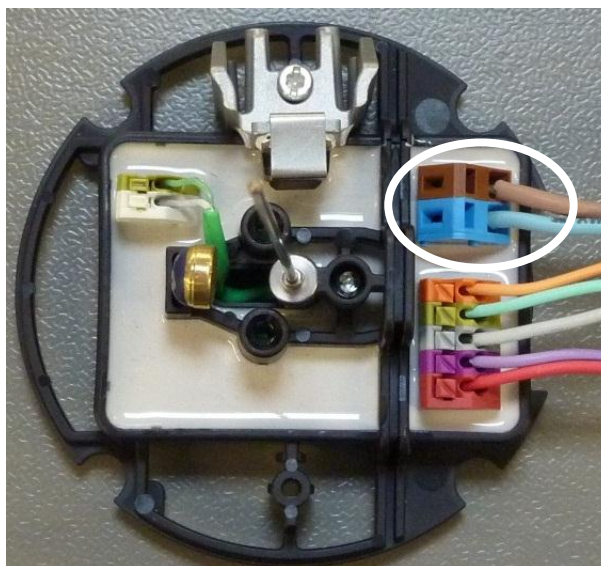
- Check all flex wires for breaks, short circuits and mechanical damages
- Check correct wiring. Terminal and flex wires are of the same color (compare with illustration)

- Incorrect flex wires connection causes destruction of the electronic circuit boards!

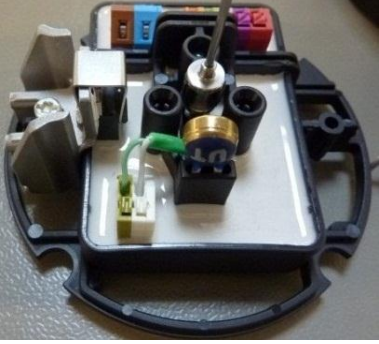
| | <ul style="list-style-type: none"> • Check thermocouple for mechanical damages • Check correct connection of thermocouple (observe color code; short circuits caused by untwisted ends of flex wires) |

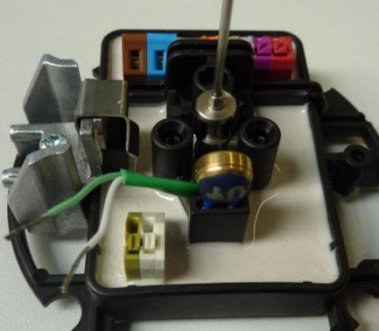
| | <ul style="list-style-type: none"> • Measure ambient temperature • Disconnect thermocouple flex wires from terminal (press terminal lever with screw driver; extract flex wires) • Connect thermocouple to thermometer (calibration: Type K) <ul style="list-style-type: none"> ➔ Ambient temperature ($\pm 5^{\circ}\text{C}/10^{\circ}\text{F}$) • Heat thermocouple by using a hot air tool <ul style="list-style-type: none"> ➔ Temperature must increase • Short-circuit both thermocouple flex wires (green and white) • Measure resistance between short-circuited flex wires and thermocouple jacket <ul style="list-style-type: none"> ➔ Resistance $> 1\text{M}\Omega$ |

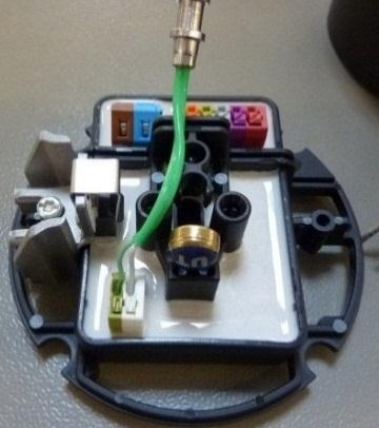
| | <ul style="list-style-type: none"> • Replace thermocouple when indicated • Extract thermocouple from its support • Connect thermocouple to replacement electronic circuit board: Press terminal levers with a screw driver, connect thermocouple flex wires and insert thermocouple in support until it snaps in |

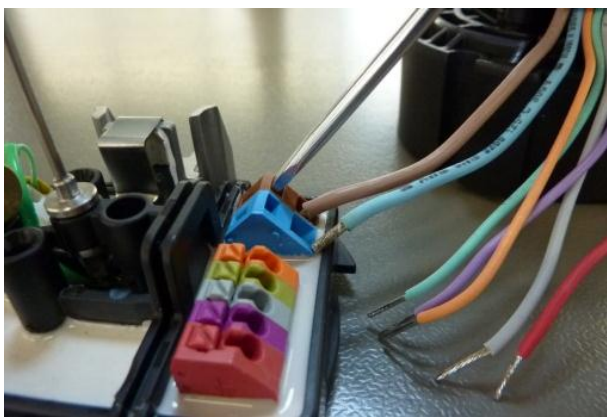
| | Power supply (blue and brown flex wire): Press slotted screw driver in terminal, extract flex wires |

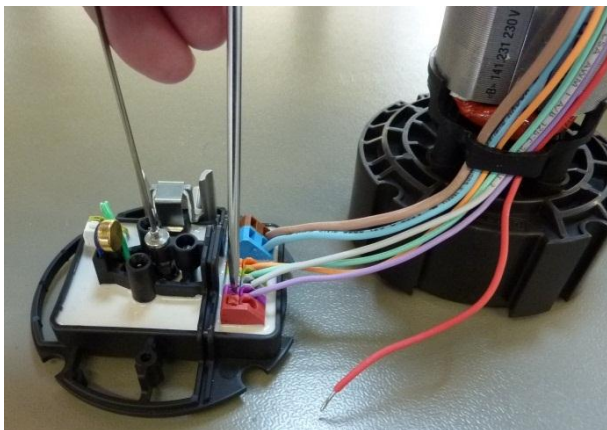
| | Signal lines: Press terminal lever with a screw driver; extract flex wires |

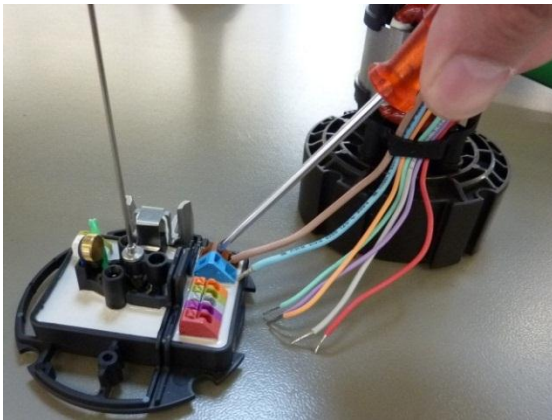
Power supply (blue and brown flex wire): Press slotted screw driver in terminal, connect flex wires

Signal lines: Connect flex wires without operating terminal levers; make sure terminal color corresponds with flex wire color

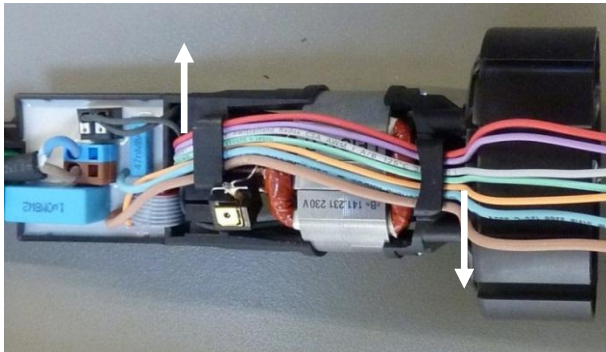
Extract flex wires off the support

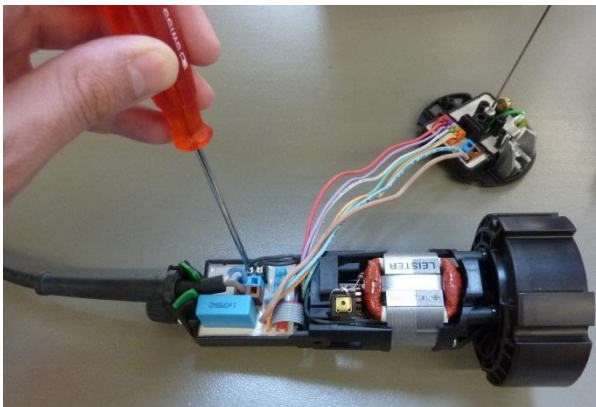
Remove motor flex wires from terminals: Press terminal lever by using a screw driver, extract flex wires

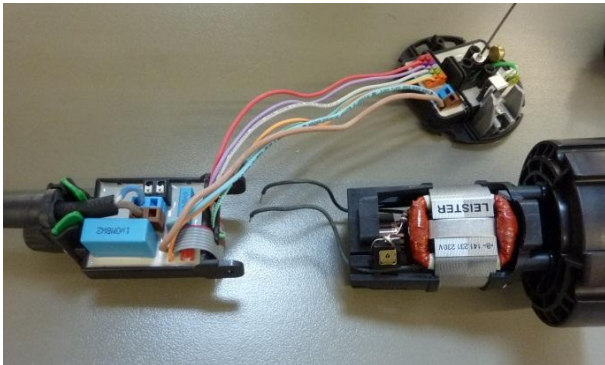
Detach rear electronic circuit support which is snapped on the motor end bell

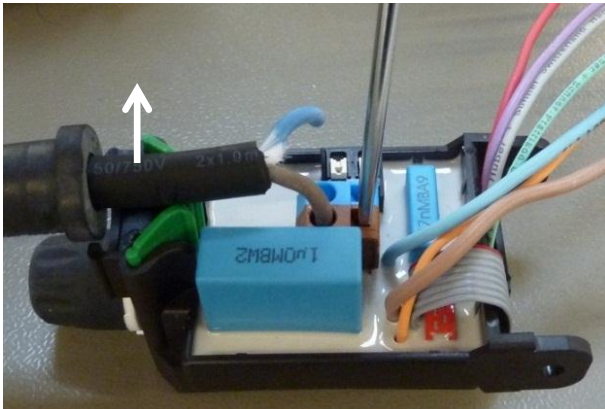
Remove power supply cord: Press slotted screw driver (size 1) in terminal, extract flex wires

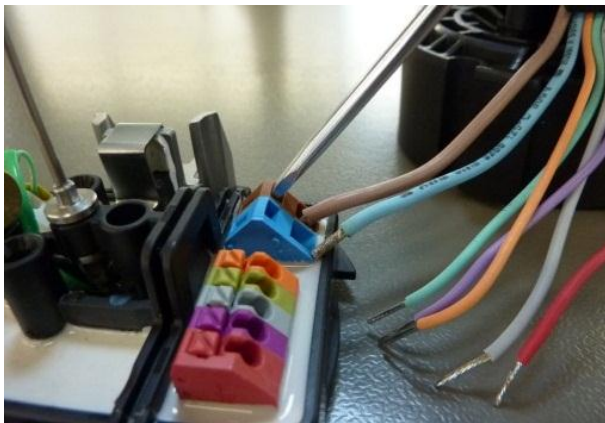
Power supply (blue and brown flex wire): Press slotted screw driver (size 1) in terminal, extract flex wires

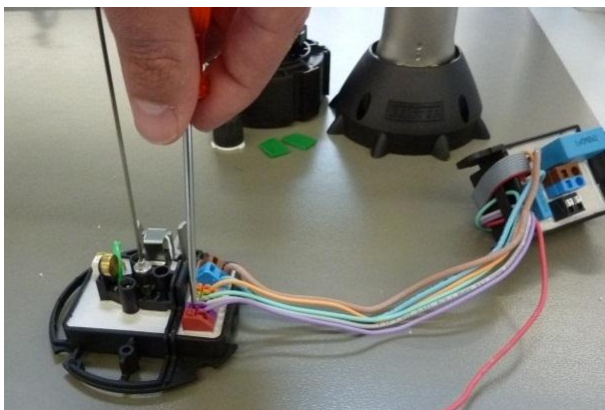
Remove signal lines from terminals: Press terminal lever with a screw driver; extract flex wires

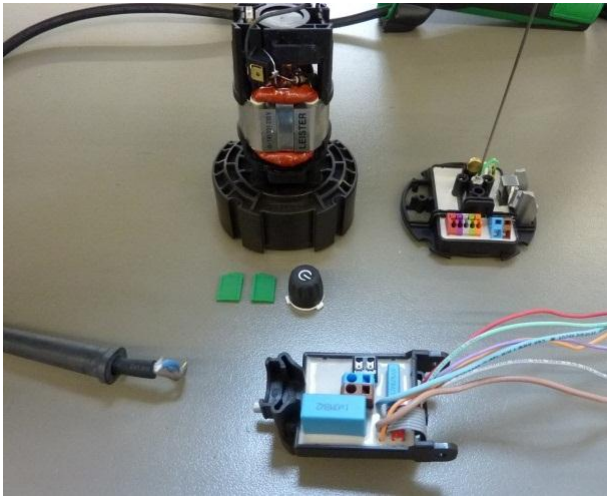
| | Remove e-Drive control button knob and strain relief clamps from electronic circuit board support |

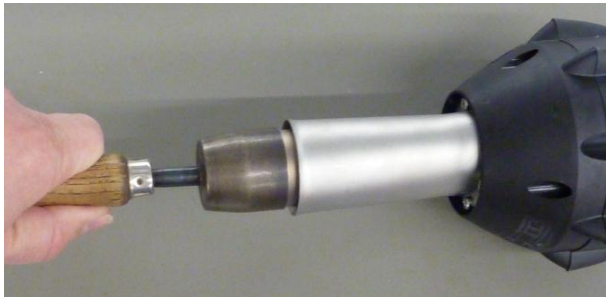
Attach covering cap to heater tube (block air outlet)

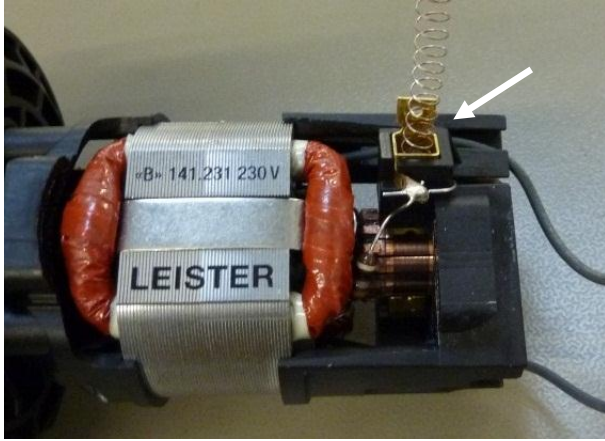
Carefully bend up the ear of the carbon brush support and remove carbon brush
Caution, spring is under tension!
Notice fitting position

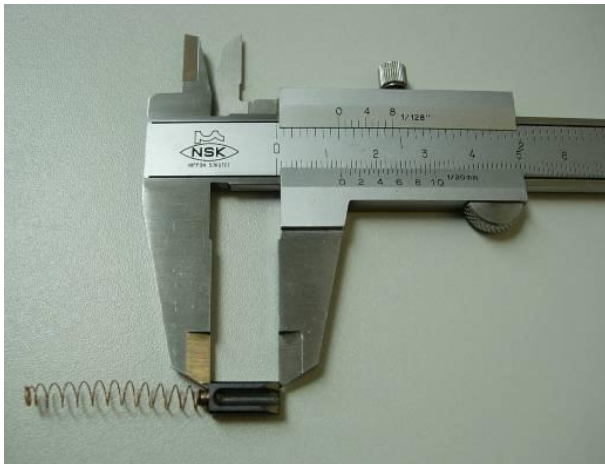
Measure length of carbon brush
Check contact surface for scorch marks
(if a "carbon brush jam" is detected replace carbon brushes as well as carbon brush supports)
Check both carbon brushes!

Remove carbon brushes, measure its length and replace them if their length measure 4mm or even less. Check both carbon brushes! If the carbon brushes are to be replaced reset timer "Service recommended" in the service menu (chapter 5.3). If the carbon brushes are not to be replaced make sure to re-insert them the same way (abrasion). *Calliper gauge, scale*

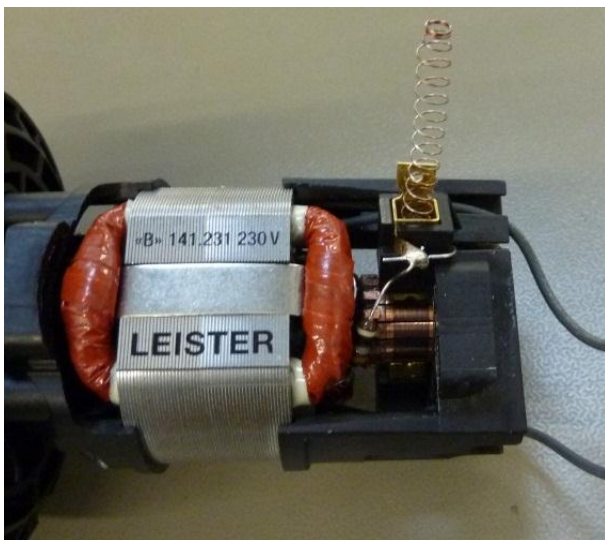
Re-insert the carbon brushes in the same fitting position

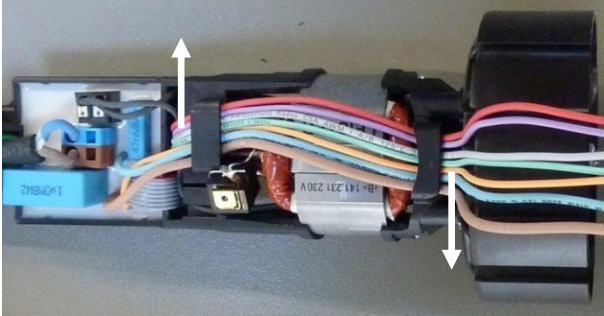
| | Remove motor flex wires: Extract flex wires off the supports on the motor |

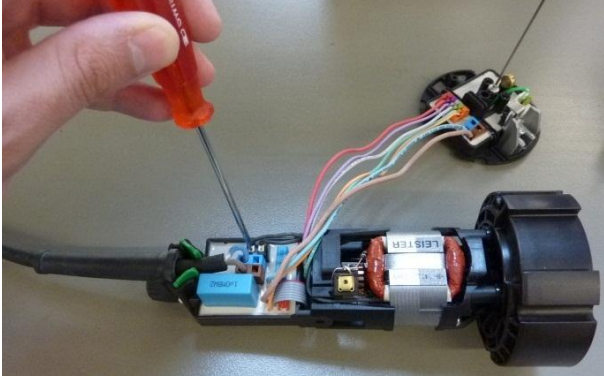
| | Remove motor flex wires: Press terminal levers by using a screw driver, extract flex wires |

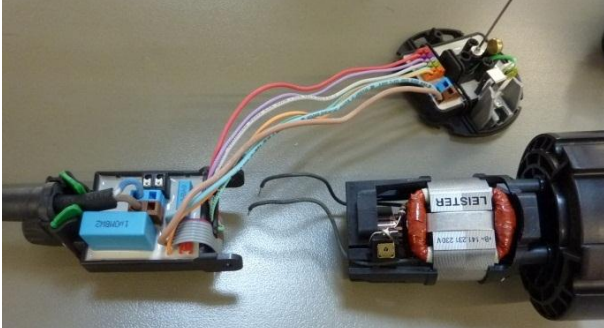
| | Detach rear electronic circuit support which is snapped on the motor end bell |

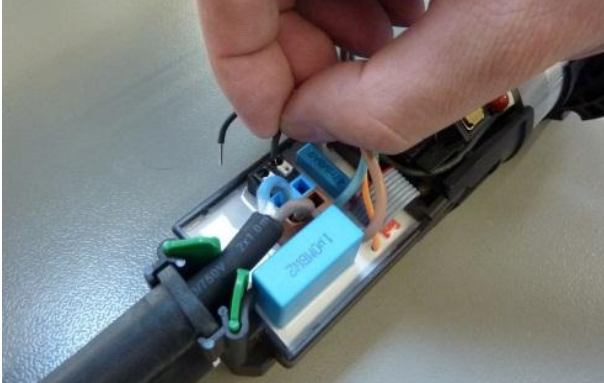
| | Reassemble tool in reverse order, terminate assembling according to chapter 6.2 Note: Connect motor flex wires without operating terminal levers Reset timer "Service recommended" in the service menu (chapter 5.3) |

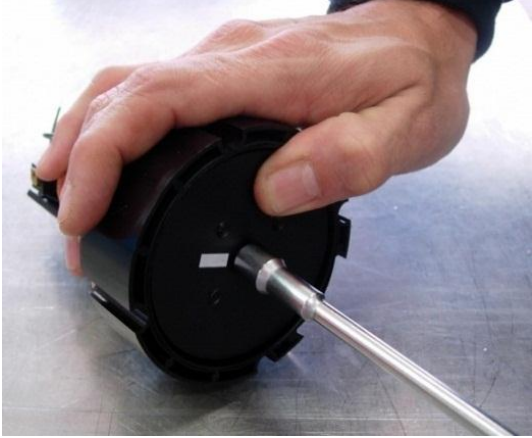
| | <p>Loosen hexagon nut by using a socket wrench (no. 8)</p> |

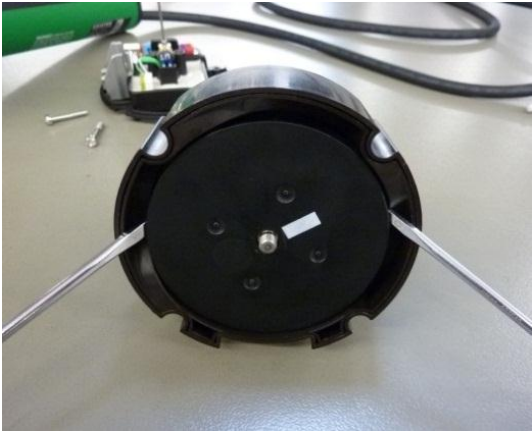
| | <p>Remove upper impeller by using two screw drivers</p> |

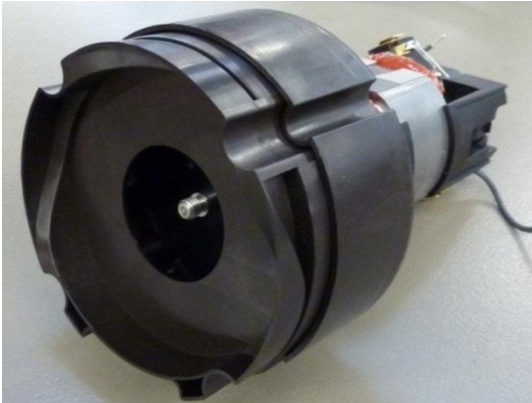
| | <p>Remove deflector</p> |

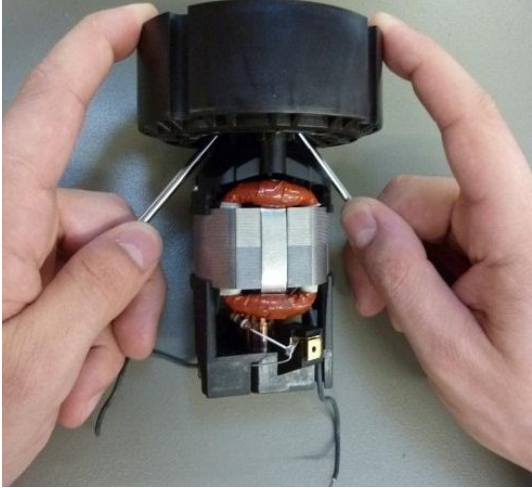
| | <p>Move the lower impeller to the top; as soon as it is enough far from the bottom, it may be removed the same way as the upper turbine.</p> <p>Note: After extraction the impellers are damaged and not to be used anymore!</p> |

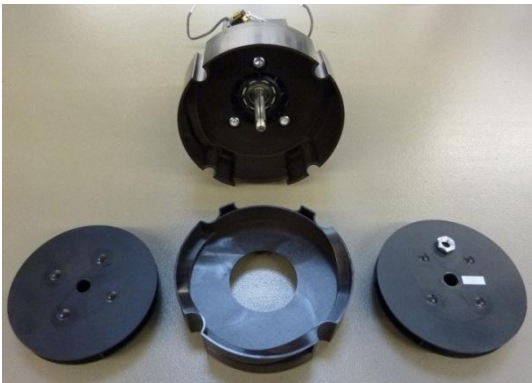
| | <p>Assemble replacement impellers in reverse order</p> <p>Note: The deflector is asymmetrically shaped; there is just one fitting position</p> |

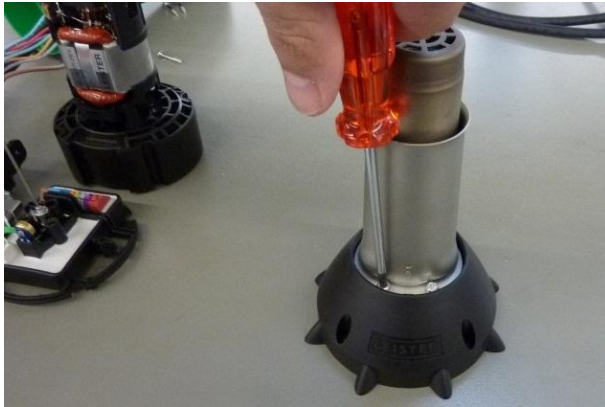
Loosen PT pan head cap screws KA35x20 (4x) and remove heater tube with mica tube

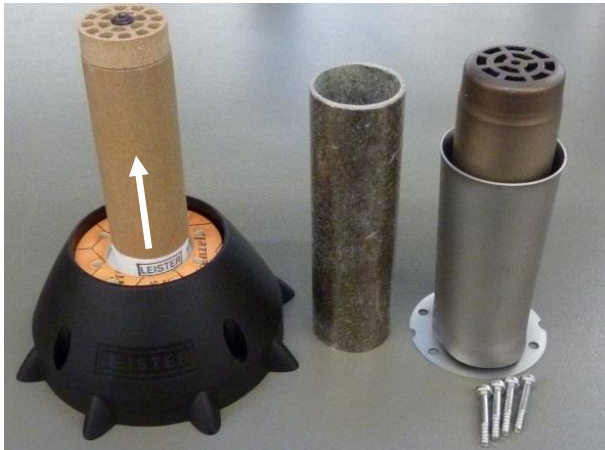
Heating element may be removed now; gasket will be extracted with heating element from the blower housing top

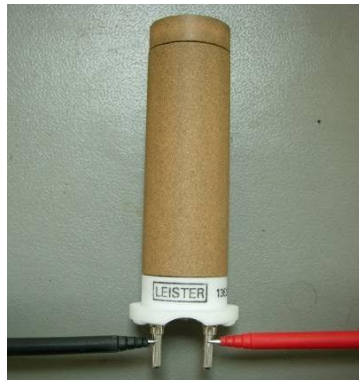
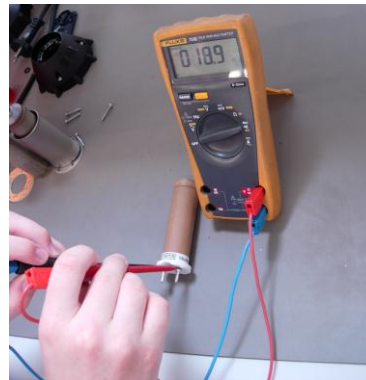
- Do a visual check of the heating element at every repair; replace the heating element if it is either mechanically damaged or if any heating channels are clogged
- Check resistance of heating element by using an ohmmeter

| Voltage [V] | Power [W] | Resistance [Ω] |
| 100 | 1350 | approx. 7 |

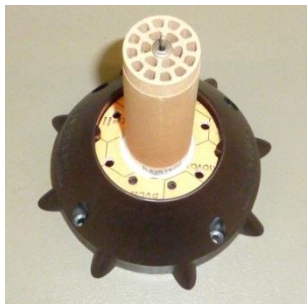
| | <p>Insert gasket; make sure both grooves match cams of blower housing top</p> |

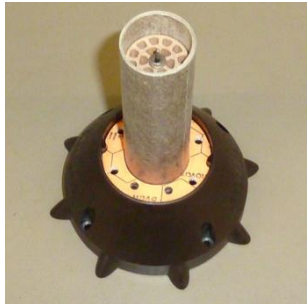
| | <p>Cover heating element with mica tube; ensure by slightly turning the mica tube passes through the gasket</p> <p>Note: If the heating element must be replaced, the mica tube usually must be replaced as well</p> |

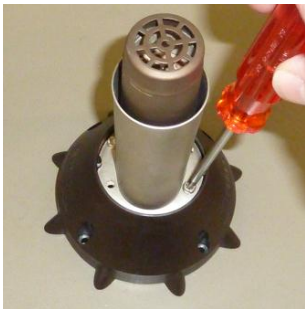
Tighten PT pan head caps screws KA35x20 (4x) to cross

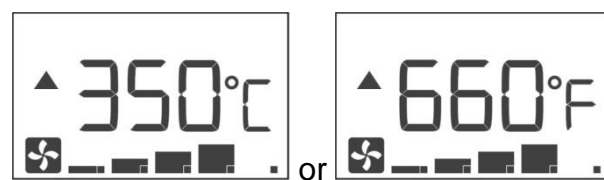
| | | Turn e-Drive control button at least one step clock- and one step counterclockwise (temperature setting) Press e-Drive control button and then turn at least one step clock- and one step counterclockwise (airflow setting) |

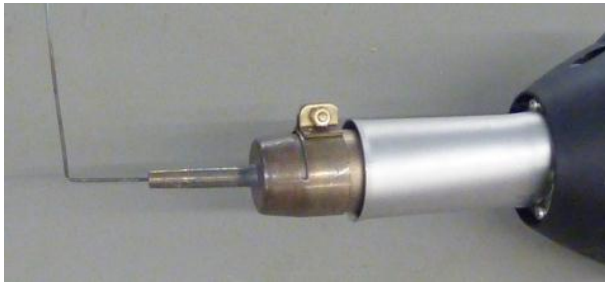
Check air outlet temperature: Insert external thermocouple 5mm into the center of the tubular nozzle; thermocouple must not touch nozzle at all

Temperature 700°C (1290°F) $\pm 20^{\circ}\text{C}$ (40°F)
If temperature is below 600°C (1110°F), the mica tube is possibly not assembled

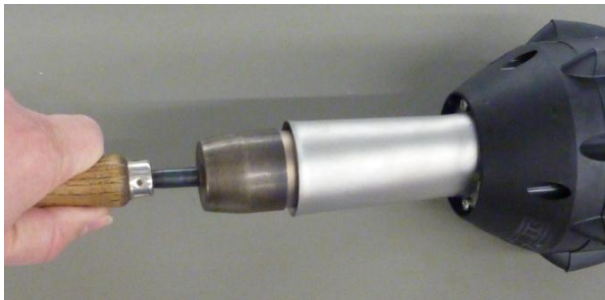
Attach covering cap to heater tube (block air outlet): After a few seconds the heating element protection circuitry must act; current/power consumption will be reduced
Remove covering cap
