Technical Service BULLETIN

Title: **TECHSTREAM ECU FLASH REPROGRAMMING PROCEDURE**

Models: **'01 – '08 Applicable Toyota**

SS002-07
SPECIAL SERVICE TOOLS

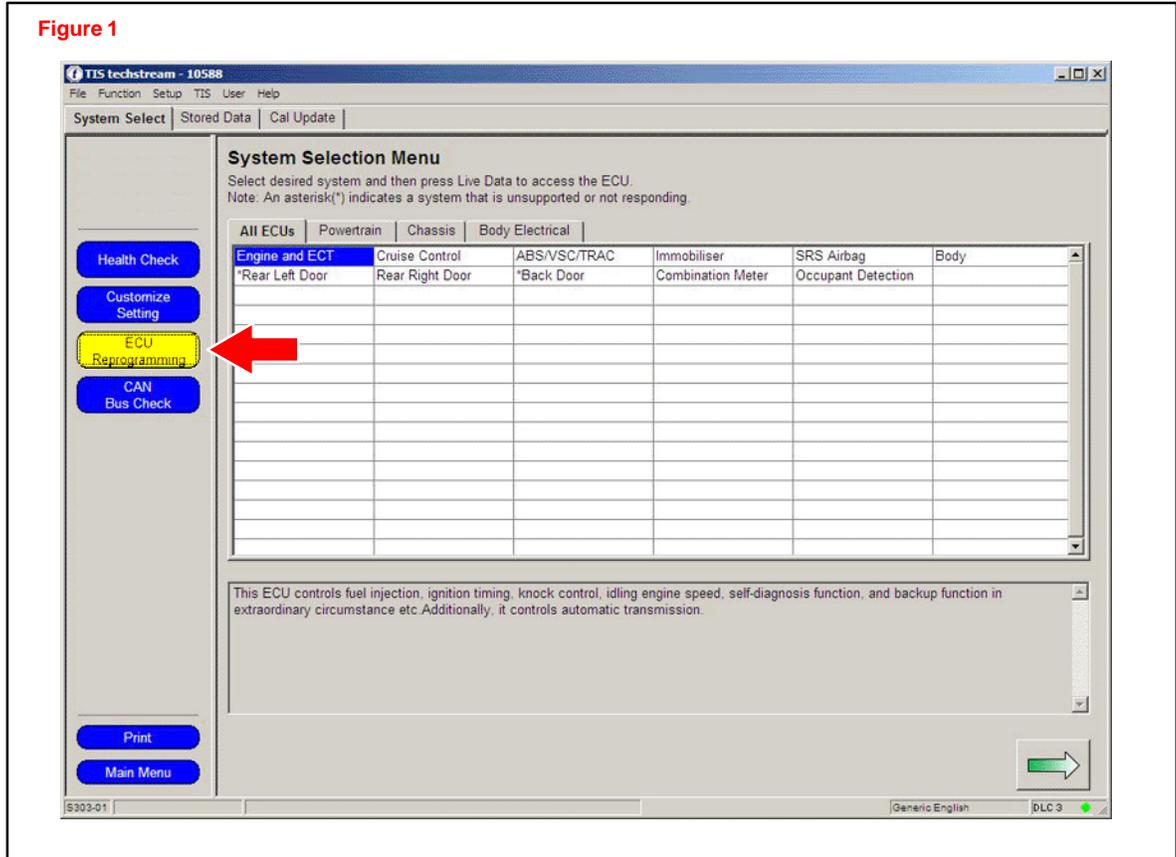
Figure 1

1. Verify the vehicle’s applicability for recalibration and locate desired calibration file.
 - A. ECU Reprogram Method:
 - a. Establish a vehicle connection.
 - b. Click the *ECU Reprogramming* button on the *System Select* tab (Figure 1).

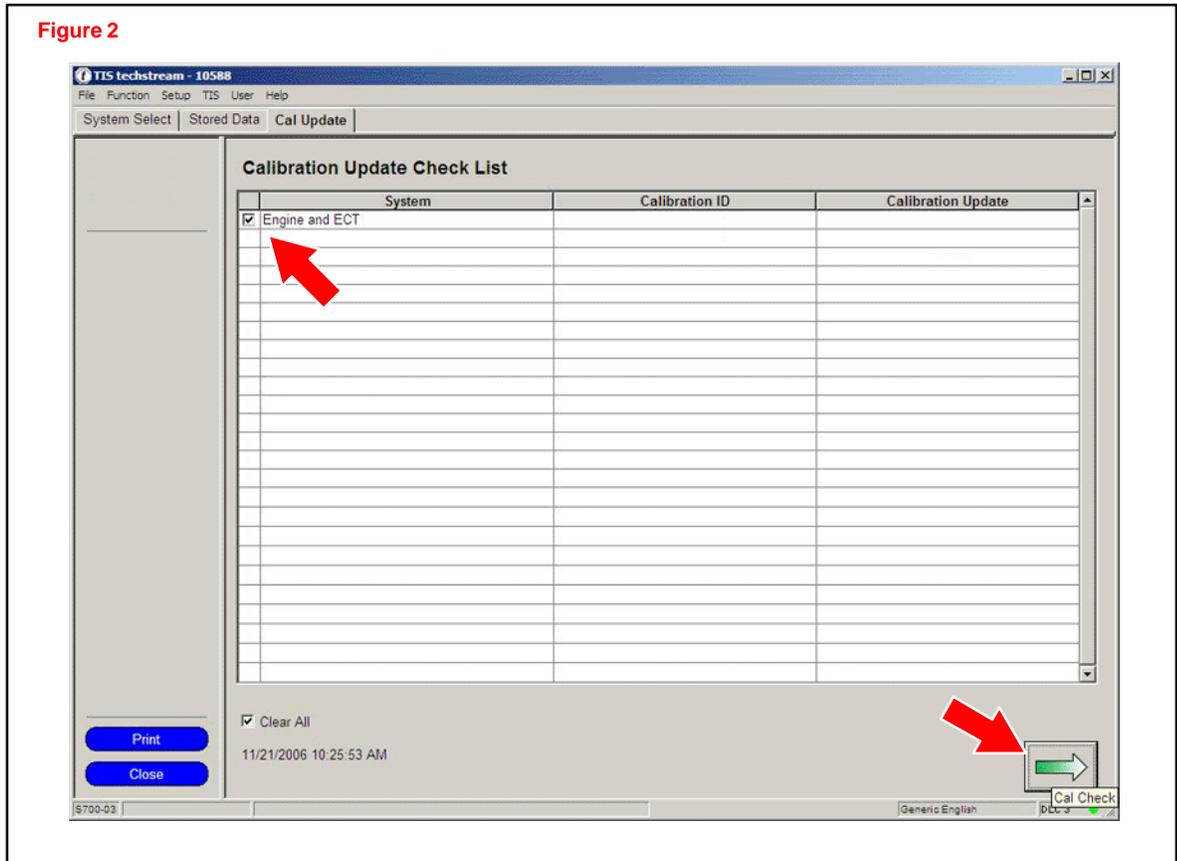
- c. Select available ECU(s) from the *Calibration Update Check List* (Figure 2).

- d. Click the green arrow button (bottom right of screen) to retrieve current calibration ID(s) and check for available calibration updates.

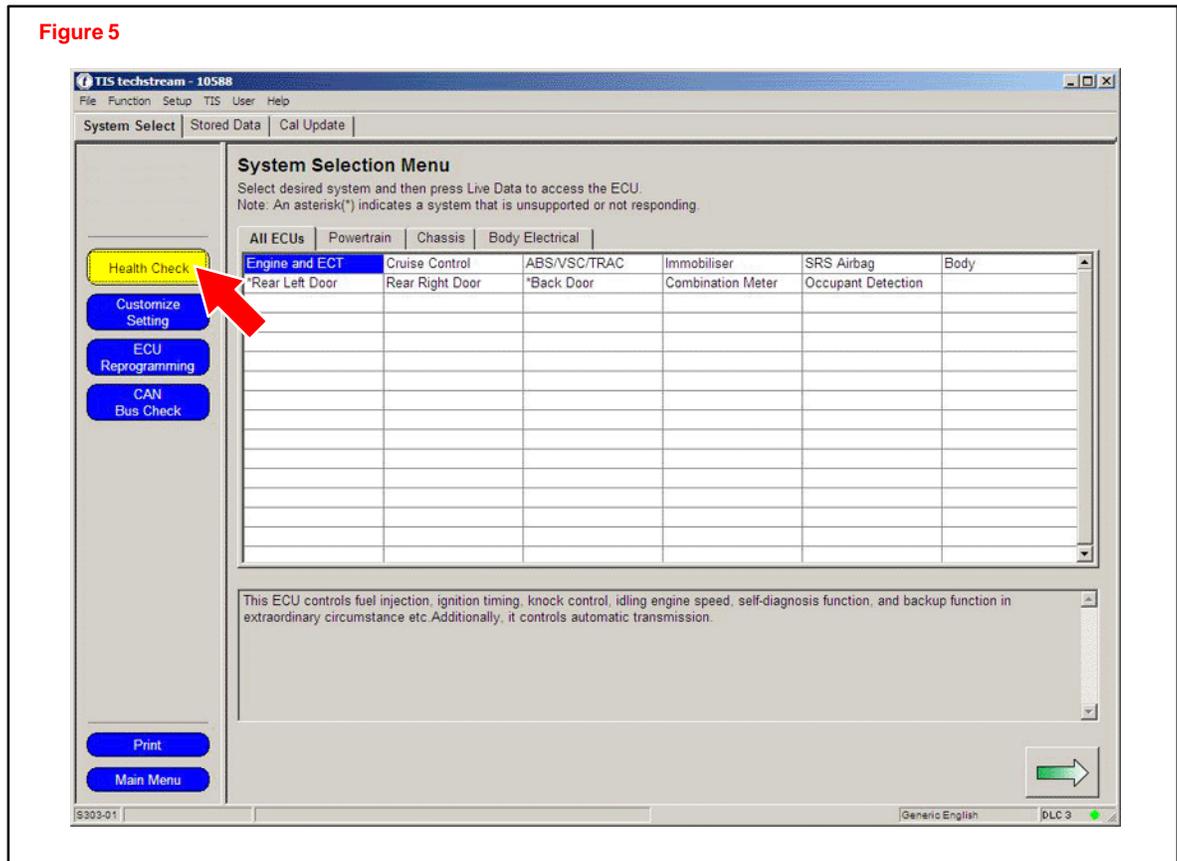
Figure 5

- B. Health Check Method.
 - a. Establish a vehicle connection.
 - b. Click the *Health Check* button on the *System Select* tab (Figure 5).

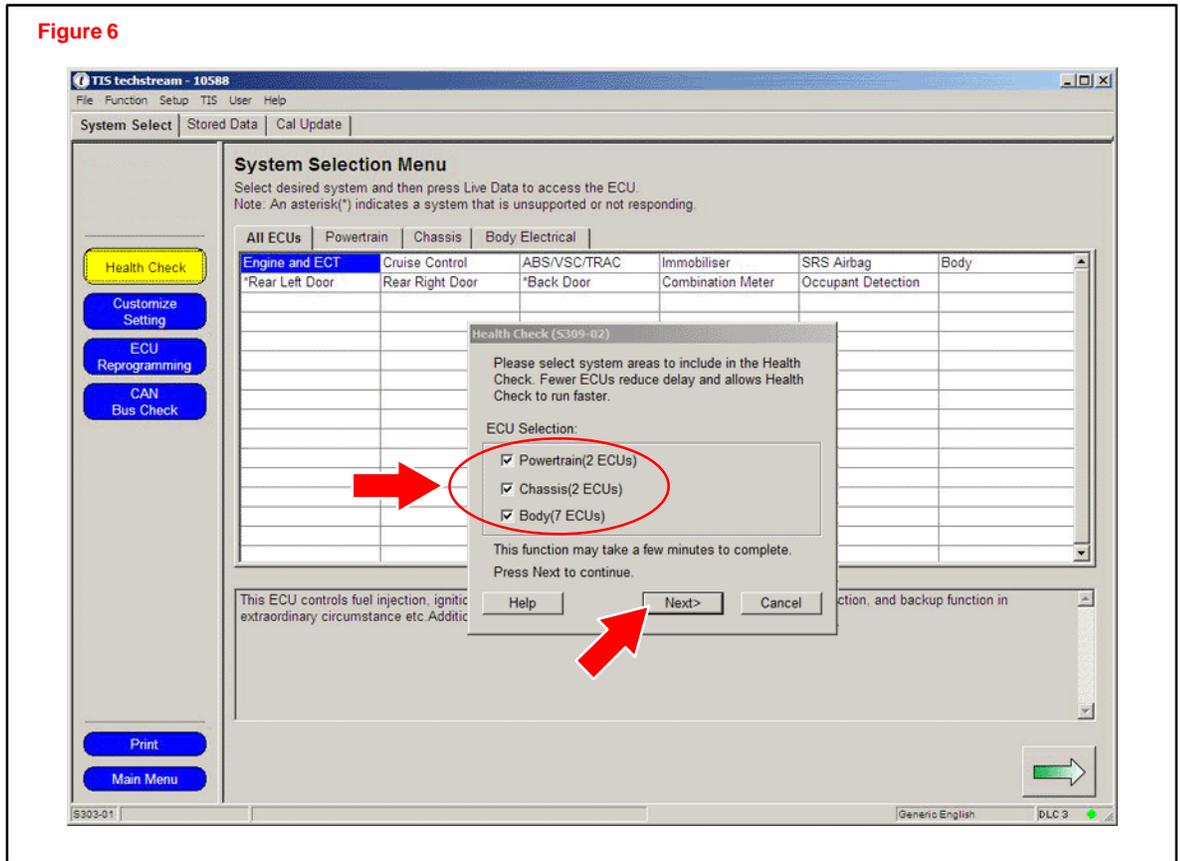
Figure 6

- c. Choose desired ECU group(s) in the *Health Check* dialog box (Figure 6).
- d. Click *Next*.

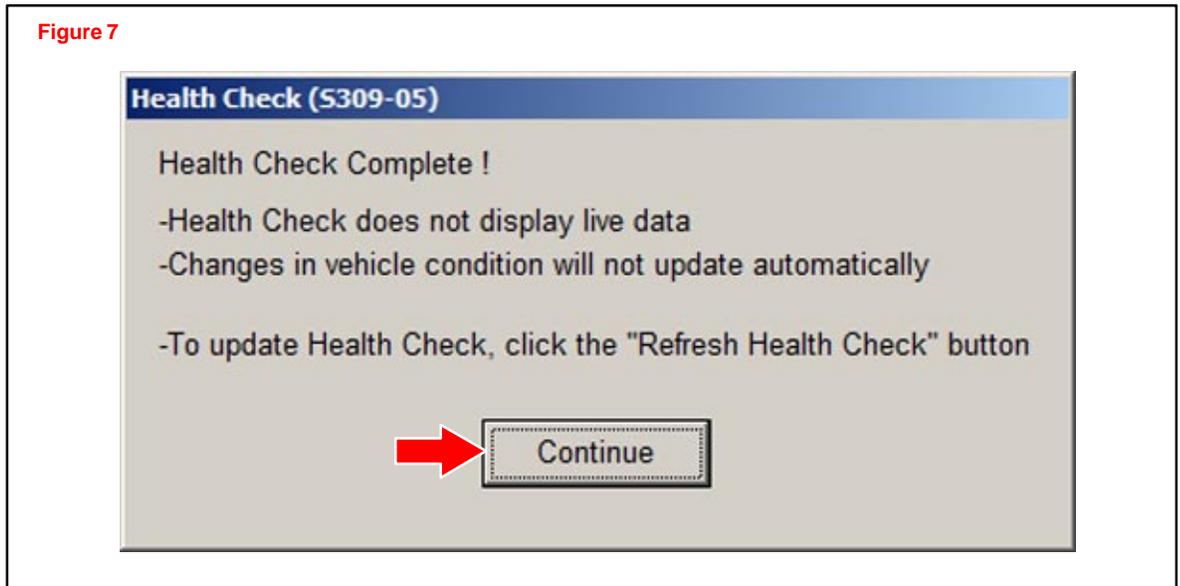
Figure 7

- e. Click *Continue* to view Health Check results (Figure 7).

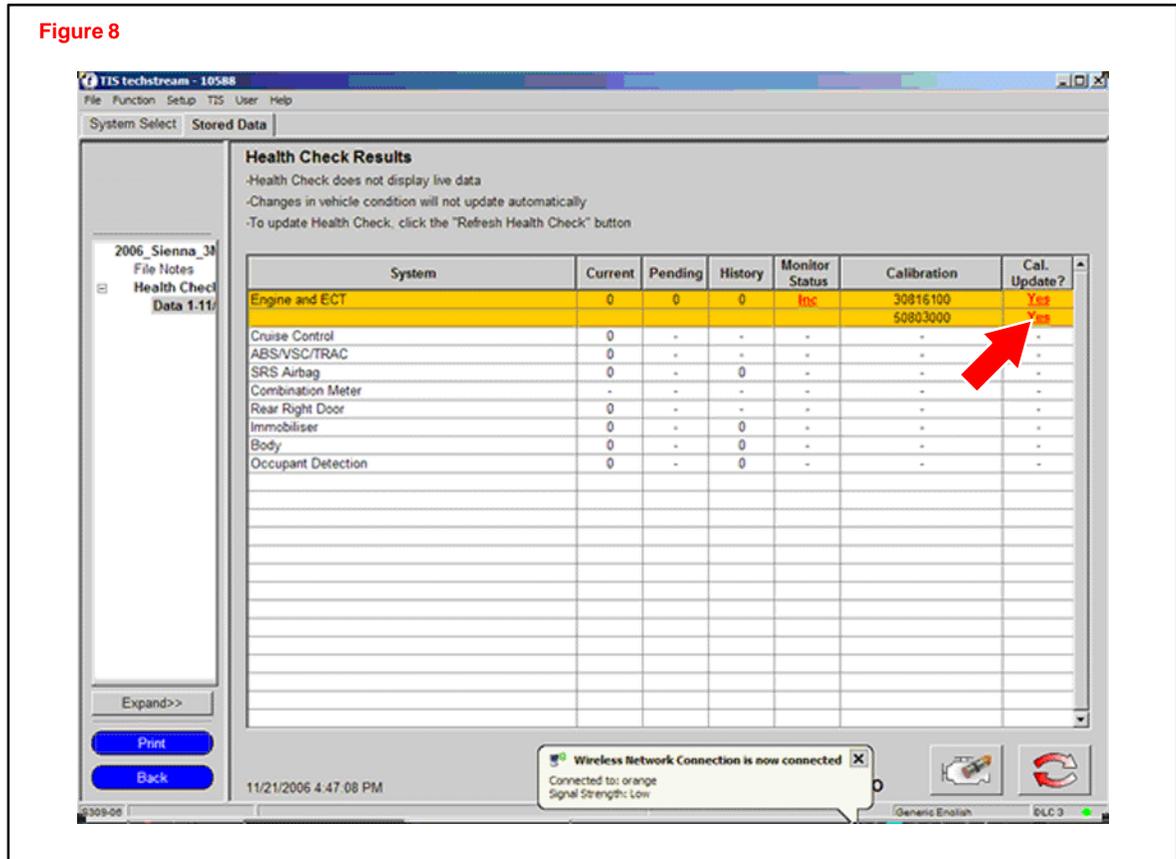
Figure 8

- f. Available calibration updates are indicated by a **Yes** link in the *Cal. Update?* column. Click the **Yes** link to access the appropriate service bulletin on TIS (Figure 8).

- Note any DTCs stored in systems that will be flash reprogrammed.
- Clicking the **Yes** link will automatically launch TIS and perform a calibration search.

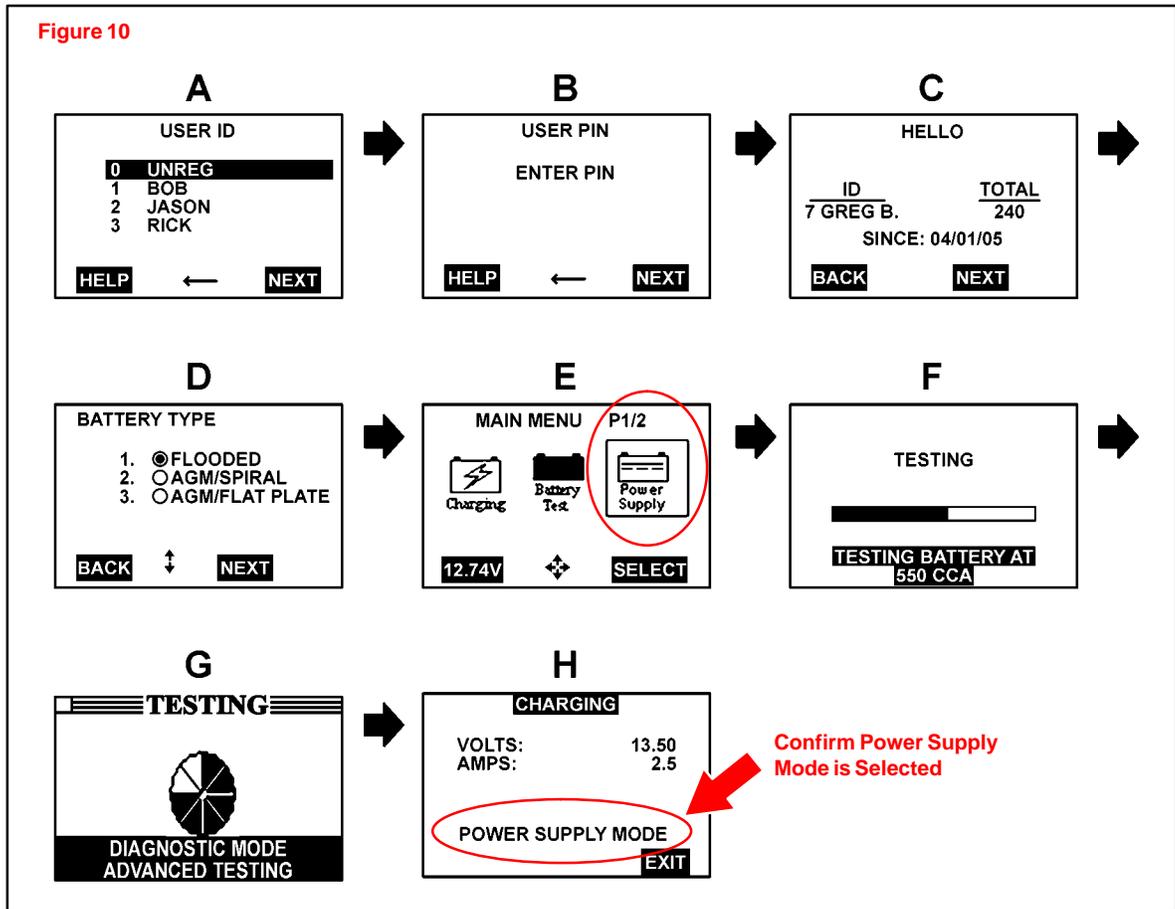
2. Connect the GR8 Battery Diagnostic Station.
 - A. Connect the GR8 Battery Diagnostic Station to the car and turn it on.
 - B. Select *Power Supply Mode* by following the screen flow below (Figure 10).

- ECU damage may occur if the correct battery charger and mode setting are NOT used.
- Power Supply Mode is used to maintain battery voltage at 13.5 volts while flash reprogramming the vehicle.
- For details on how to use the GR8 Battery Diagnostic Station, please refer to the GR8 Instructions Manual, located on TIS, *Diagnostics – Battery*.

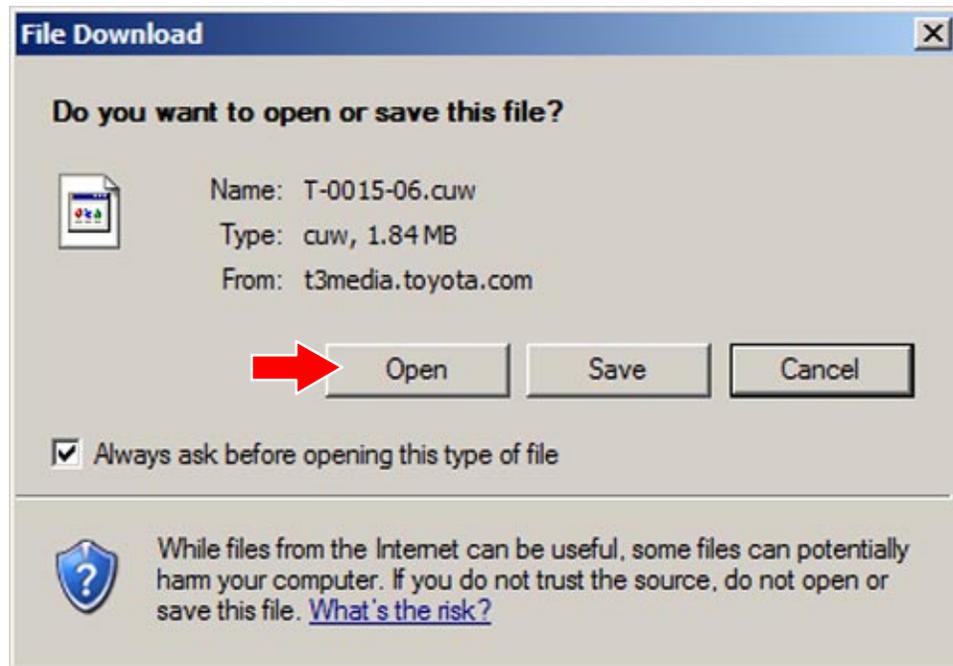
Figure 12

B. Click *Open* to load calibration file information (Figure 12).

Techstream pulls calibration files as needed to ensure the latest calibration file is used. Do NOT save calibrations locally on the hard drive or other media.

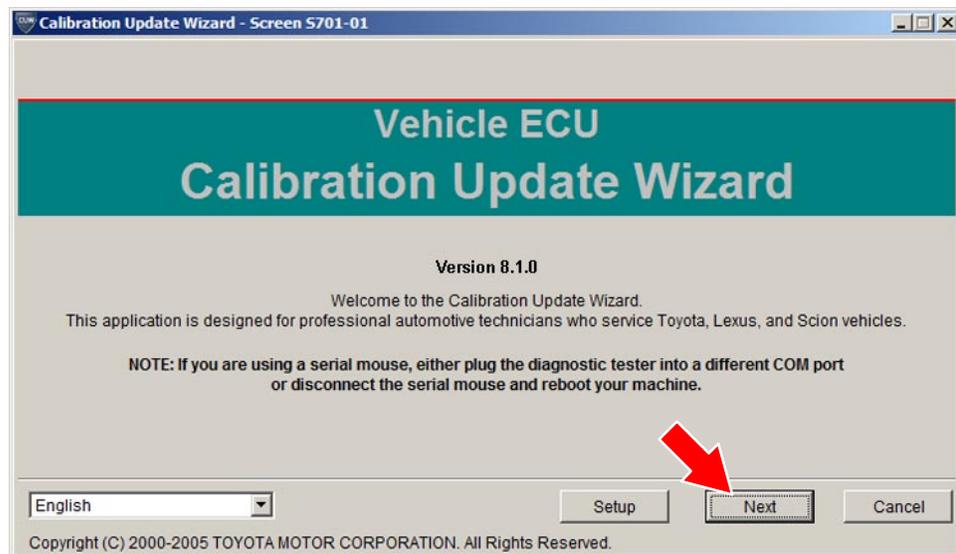
Figure 13

C. Click *Next* to start the calibration update process.

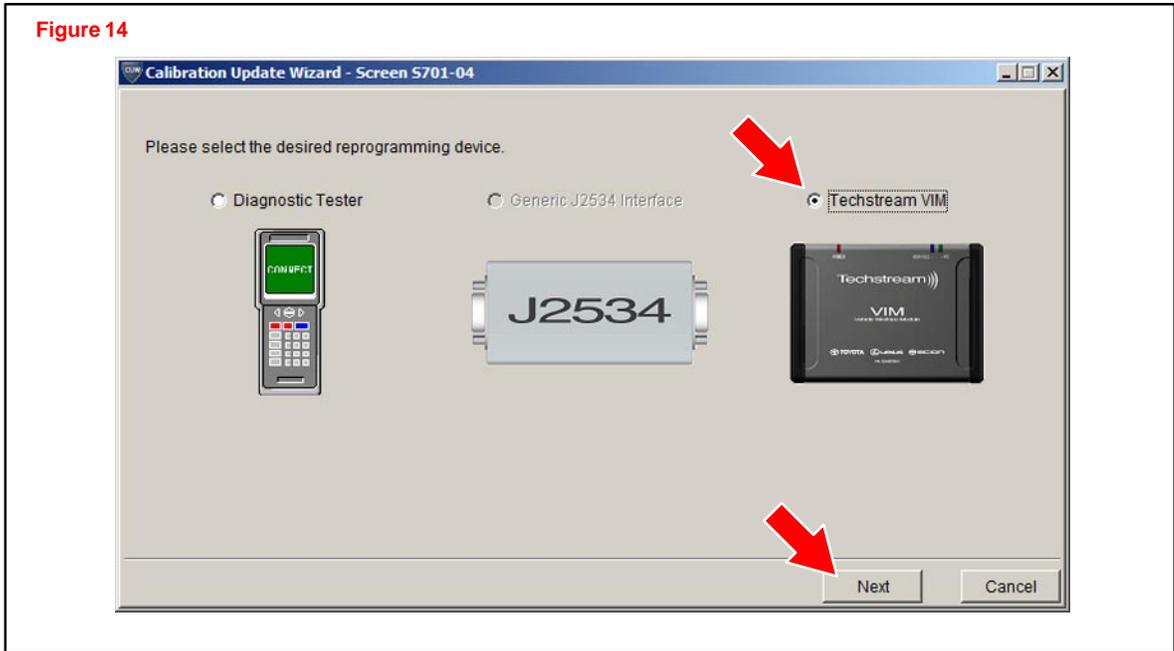
Figure 14

D. Select *Techstream VIM* as the desired programming device. Then click *Next*.

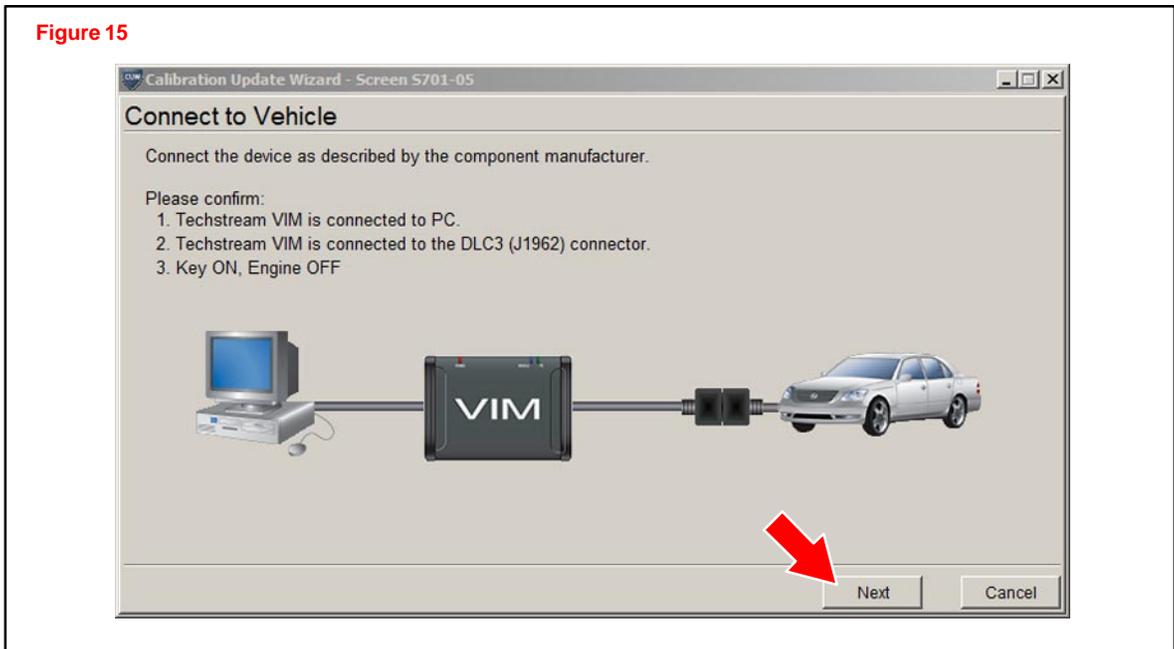
Figure 15

E. Confirm the following:

- PC is connected to VIM.
- VIM is connected to DLC3 connector.
- Ignition is ON and engine is OFF or “READY” OFF (hybrid vehicles).

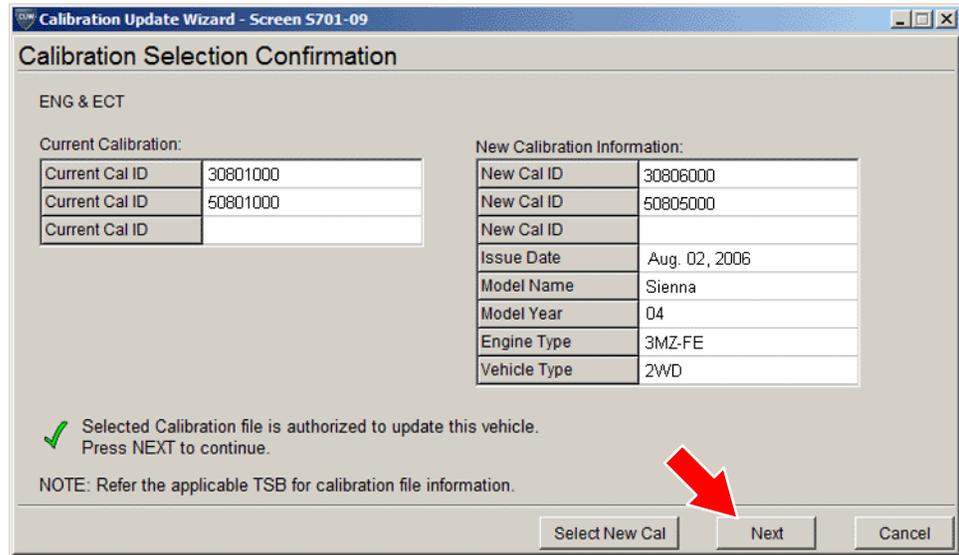
F. Verify correct current calibration and new calibration information.

- The total number of calibration IDs in the calibration file corresponds to the number of reprogrammable processors in the ECU.
- Each calibration file may contain up to three separate calibrations.
- Figure 16 shows an example of the update procedure for a two-processor ECU.

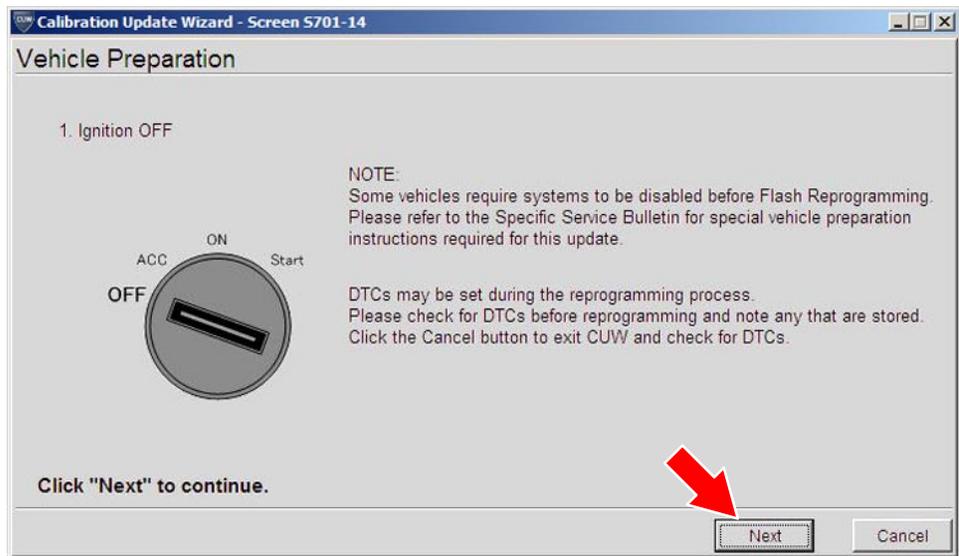
Figure 17

G. Turn ignition OFF.

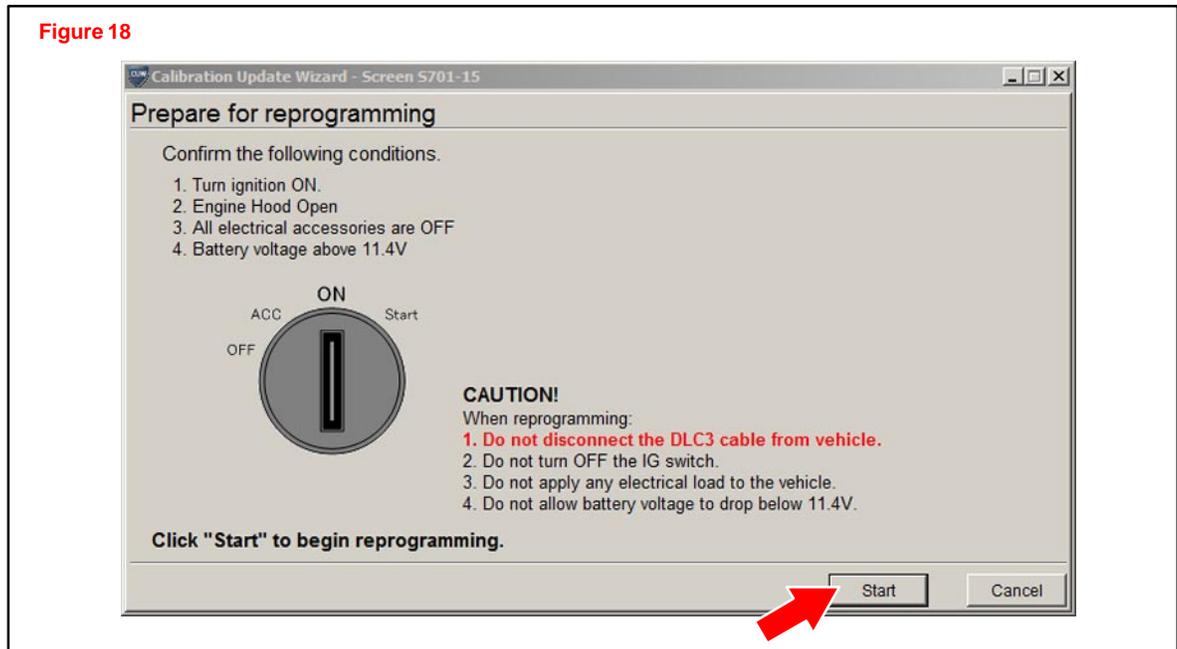
Figure 18

- H. Confirm the following:
- Ignition is ON and engine is OFF or “READY” OFF (hybrid vehicles).
 - Hood is open.
 - All accessories are OFF.
 - Battery voltage is above 11.4 volts.

Verify the vehicle is connected to a battery charger before continuing — If battery voltage falls below 11.4 volts, ECU damage may occur.

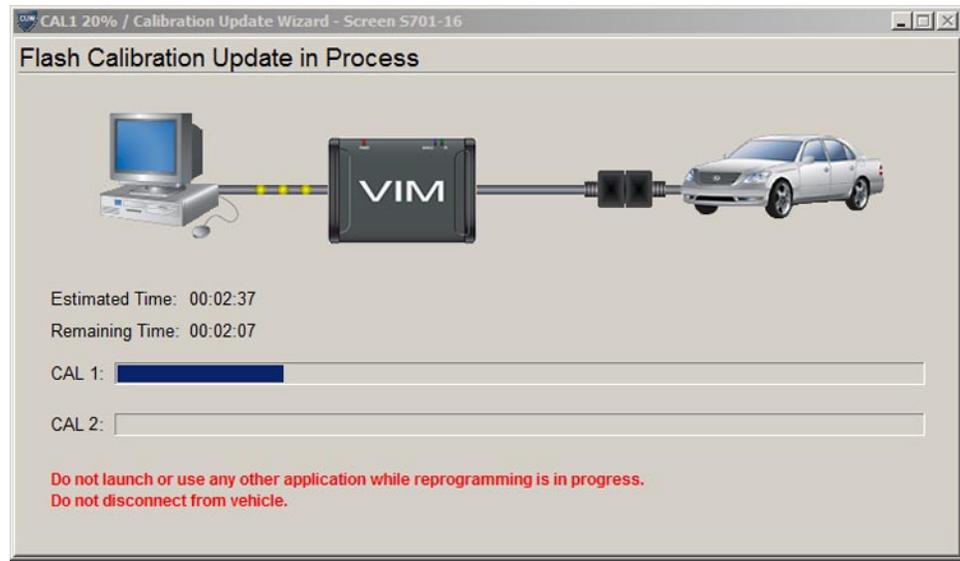
Figure 19

- I. Do NOT disturb the vehicle during flash reprogramming.

- ECU flash reprogramming may take anywhere from 3 – 30 minutes per calibration file.
- Reprogramming time will vary depending on model and ECU communication protocol. Vehicles using CAN communication protocol will reprogram much faster (2 – 7 minutes).

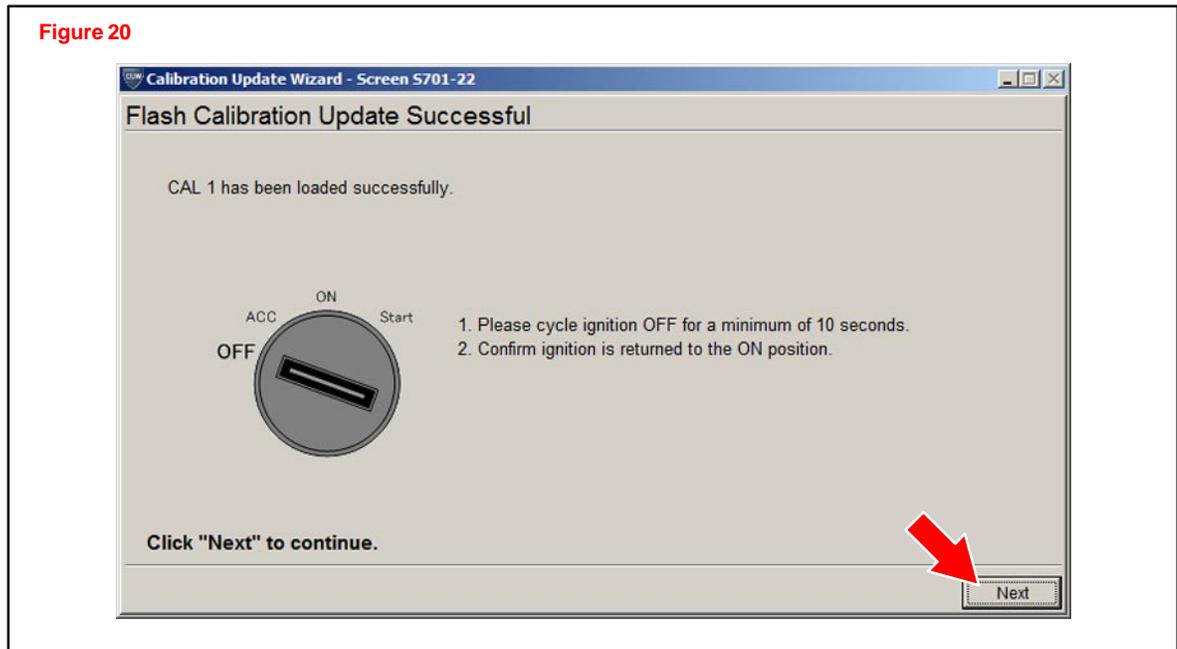
Figure 20

- J. Cal 1 has completed the update process.
- Turn ignition OFF for a minimum of 10 seconds.
 - Confirm ignition is returned to the ON position.

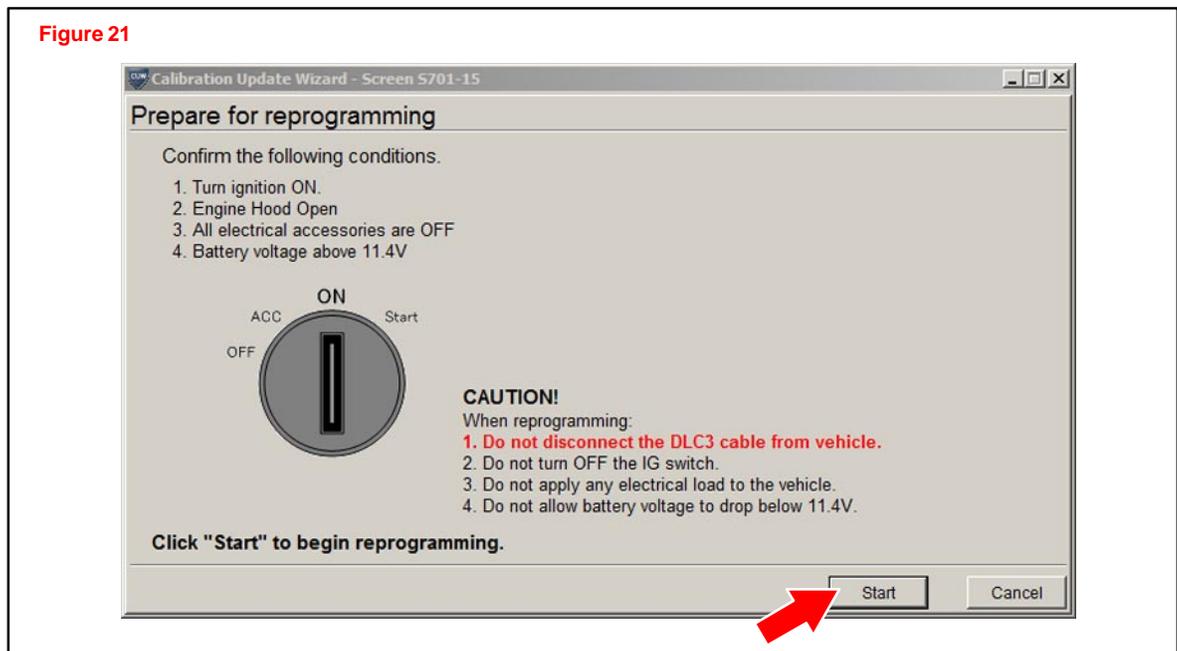
Figure 21

- K. Confirm ignition is ON.

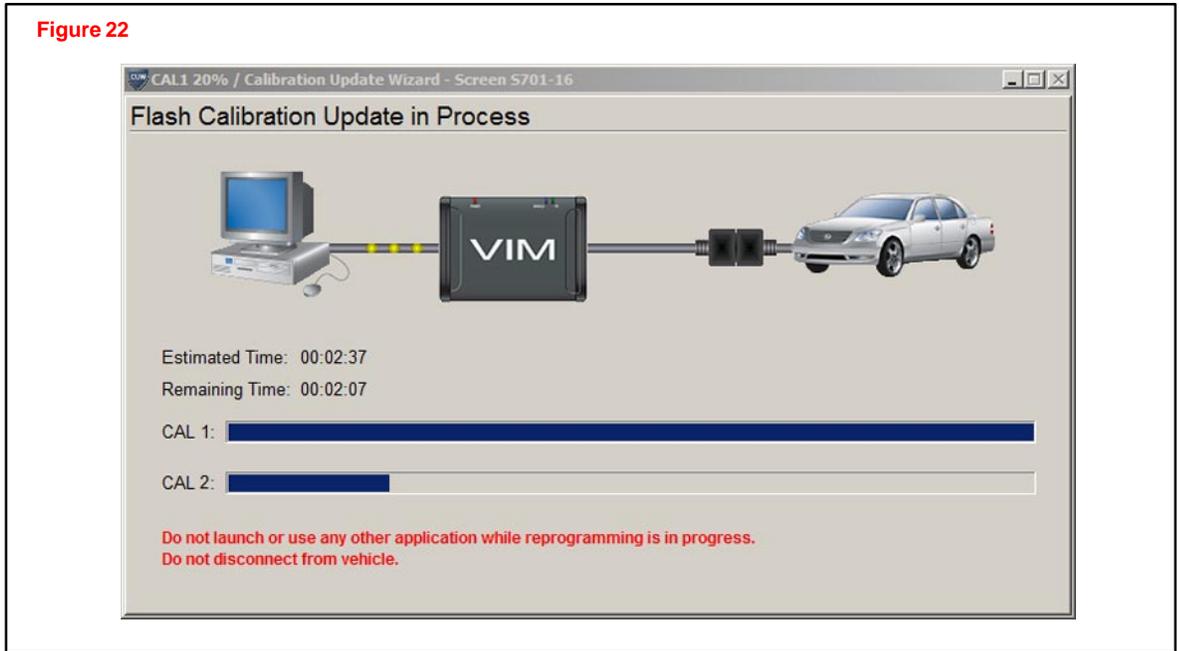
Figure 22

L. Do NOT disturb the vehicle during flash reprogramming.

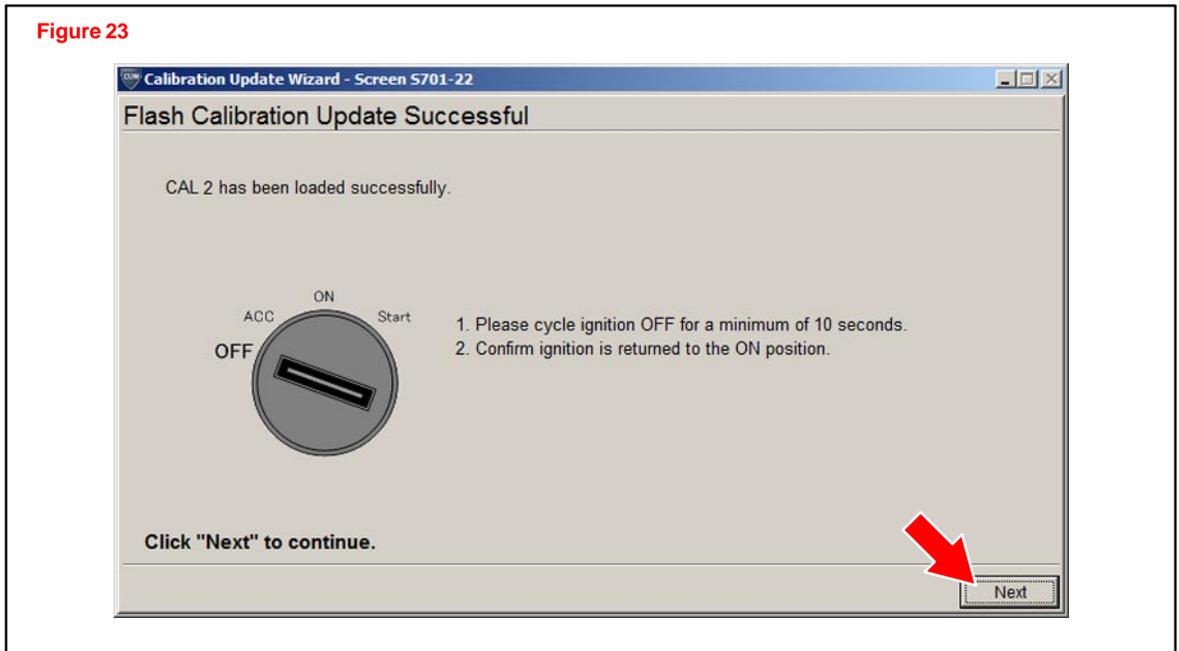
Figure 23

M. Turn ignition OFF for a minimum of 10 seconds. Then confirm ignition is returned to the ON position.

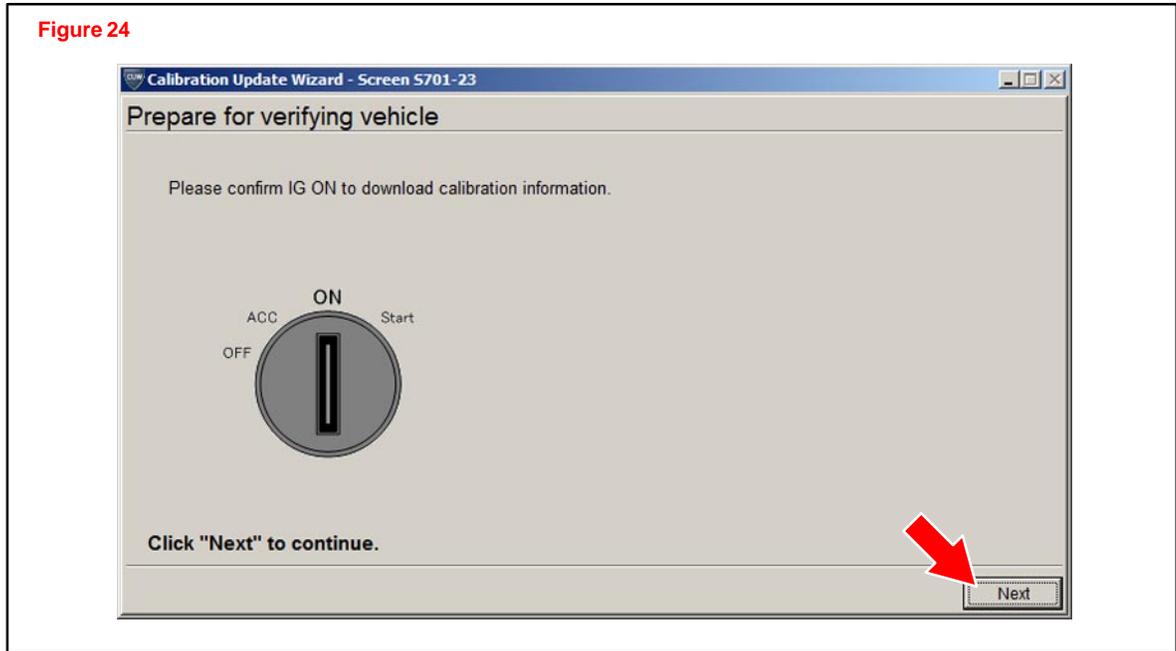
Figure 24

N. Confirm ignition is ON.

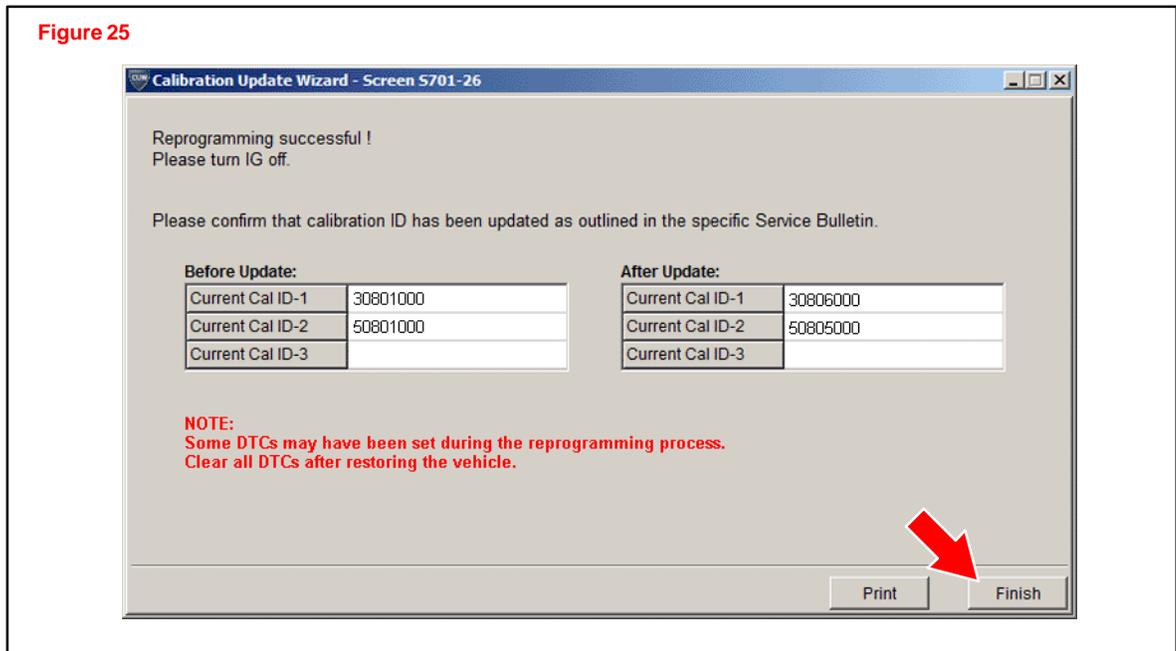
Figure 25

O. Confirm all calibrations were updated as specified in the service bulletin.
